Evaluation of low-cost, tree-mounted temperature loggers for validation of satellite-based flood mapping on the Amazon floodplain

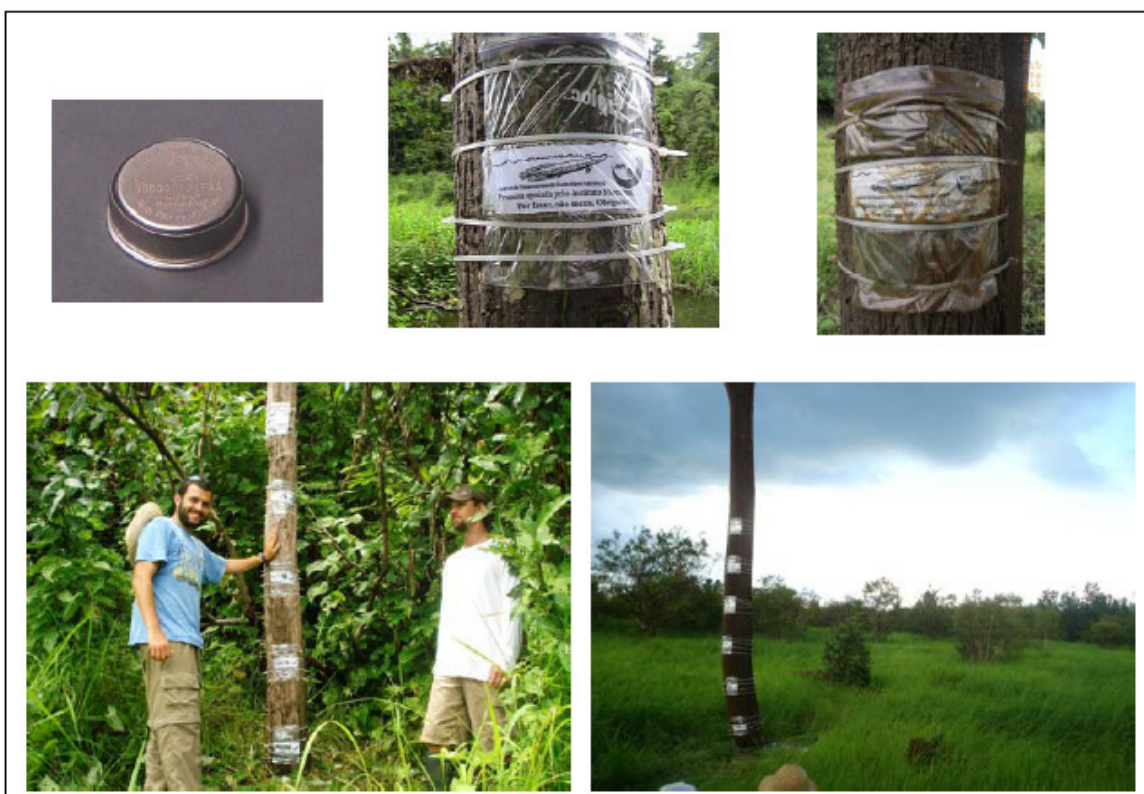
Figure 2: Upper: Thermochron iButton; iButton mount at installation; iButton mount at retrieval. Lower: Examples of iButton stations

Consisting of a computer chip enclosed in a 16 mm thick stainless steel can, the iButton is a low-cost (approximately US\$15) data logger, readable by direct contact using a probe and PC. Although certified by the manufacturer as water-resistant rather than waterproof, iButtons have been used successfully for water temperature measurement in previous studies (Dale & Miller 2007, Johnson et al. 2005) at depths of up to 5 m. The Amazon floodplain, however, presents harsh conditions for both the device and the mounting system, including submersion in several meters of water with high sediment and organic debris content and rapid current during the flood phase, and intense solar radiation during the dry phase. A field campaign was therefore designed in order to 1) determine whether iButtons would function throughout a flood season on the Amazon floodplain; 2) design a cheap, effective mounting system with minimum environmental impact; and 3) test the hypothesis that the flooded/non-flooded transition should be detectable in the iButton record owing to dampening of the diurnal temperature wave.

iButtons (model DS1921H, manufactured by Maxim Integrated Products) were deployed at the Mamirauá and Piagaçu Sustainable Development Reserves during the period 26 November to 11 December 2008. The two sites (Fig. 1) contain typical várzea habitats, and both are located at confluences of major tributaries (Japurá and Purus rivers), with resulting complex timing of flood waves. After being programmed to record temperature at 6-hour intervals, iButtons were sealed in pint-sized zip-style plastic bags, enclosed within quart-sized bags, and mounted on trees at 50 cm intervals, starting at 20 to 50 cm above ground, using plastic cable ties (Fig. 2). These iButton "station" locations were targeted for maximum along-reach and across-reach coverage.

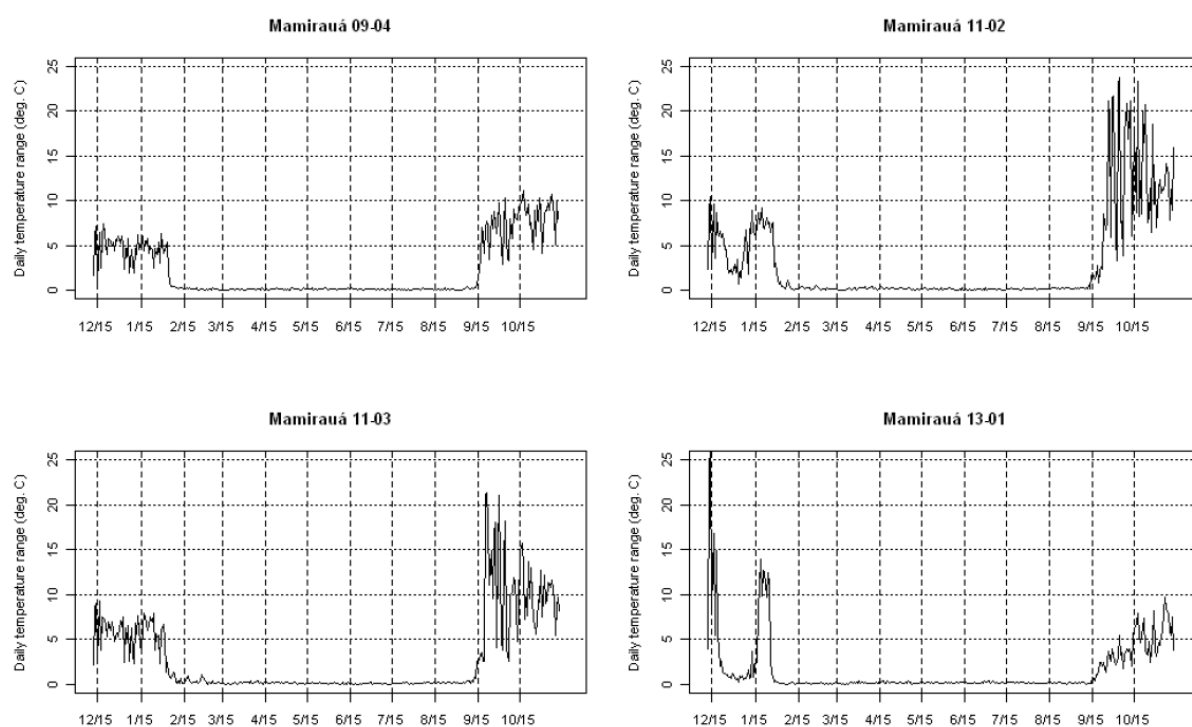
Figure 3: Daily temperature range plots for four iButton stations in Mamirauá. X axis is the date (month/day) and Y axis is temperature ($^{\circ}\text{C}$).

Examples of daily temperature range plots for four iButton stations are shown in Figure 3. Daily temperature range during the non-flooded period varied depending on iButton position above ground, aspect, and amount of canopy shading, with minimal daily ranges as low as 3 degrees and maximum ranges greater than 25 degrees. During the flooded period, the daily temperature was greatly reduced, ranging from 0 to 0.25 degrees. For iButtons 11-02 and 13-01 in Figure 3, two flooding periods can be seen: the main flood, and preceding it the "repiquete", when river stage falls slightly before rising again.

Based on 6 calibration iButtons attached to staff gauges in Mamirauá Lake, the date of flooding could be estimated within ± 3 days. Several metrics including daily minimum temperature, daily temperature range, and rate of change of daily minimum temperature or temperature range, have been evaluated. It is recommended that further gauge-based comparisons be conducted before definitive conclusions can be made regarding the optimum metric for identifying dates of flooding and emergence.
